**SPILLWAY TESTS CONFIRM
MODEL-PROTOTYPE CONFORMANCE**

By A. J. Peterka

Engineering Monograph

No. 16

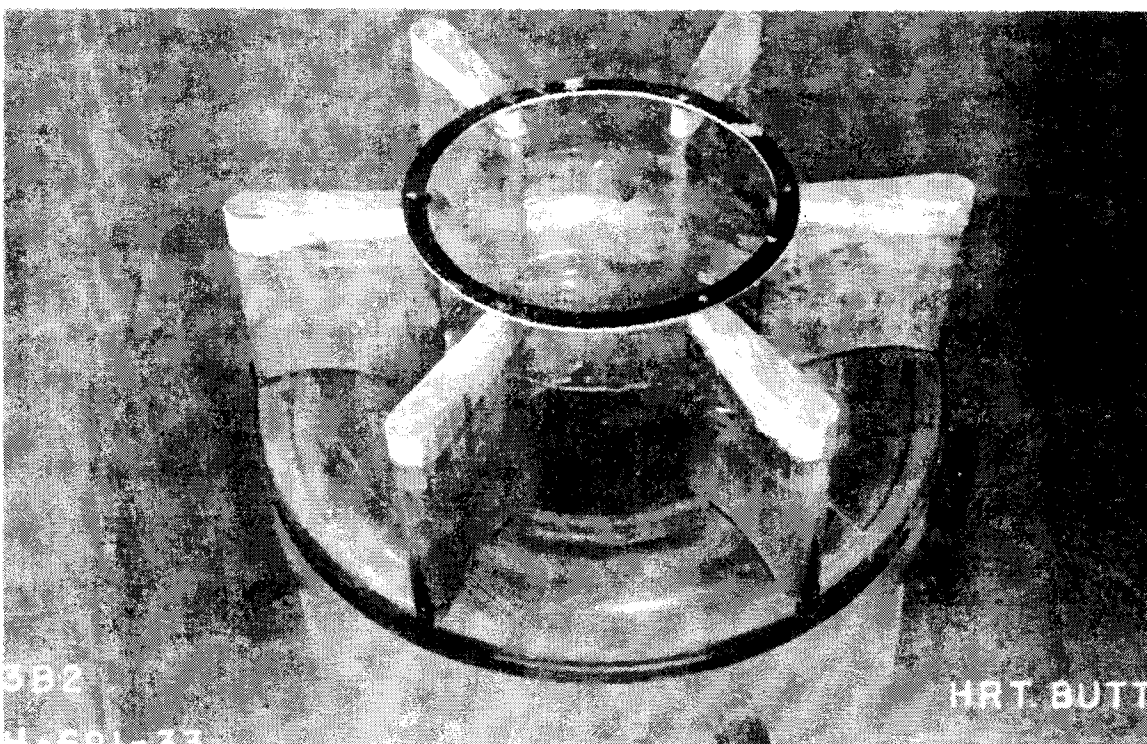
A--A violent vortex formed in the spillway at heads exceeding the submergence point. The tail of the vortex extended downward into the horizontal tunnel.

Vortices which formed in the model when the spillway was submerged, figure 4A, were thoroughly investigated both experimentally and mathematically. Since these same vortices could form to scale in the prototype, attempts were made to eliminate them. Various arrangements of piers, dividing walls, and floating and fixed rafts were tested. As a result, six spillway crest piers were recommended for use on the prototype, see figure 4B. It was found unnecessary to extend the piers as high as the maximum headwater elevation, a distance of 54 feet. Since vortex action diminished rapidly when the head on the crest approached 14 feet, it was necessary to extend the piers only to this height.

B--Six piers placed radially on the crest reduced the vortex to negligible size.

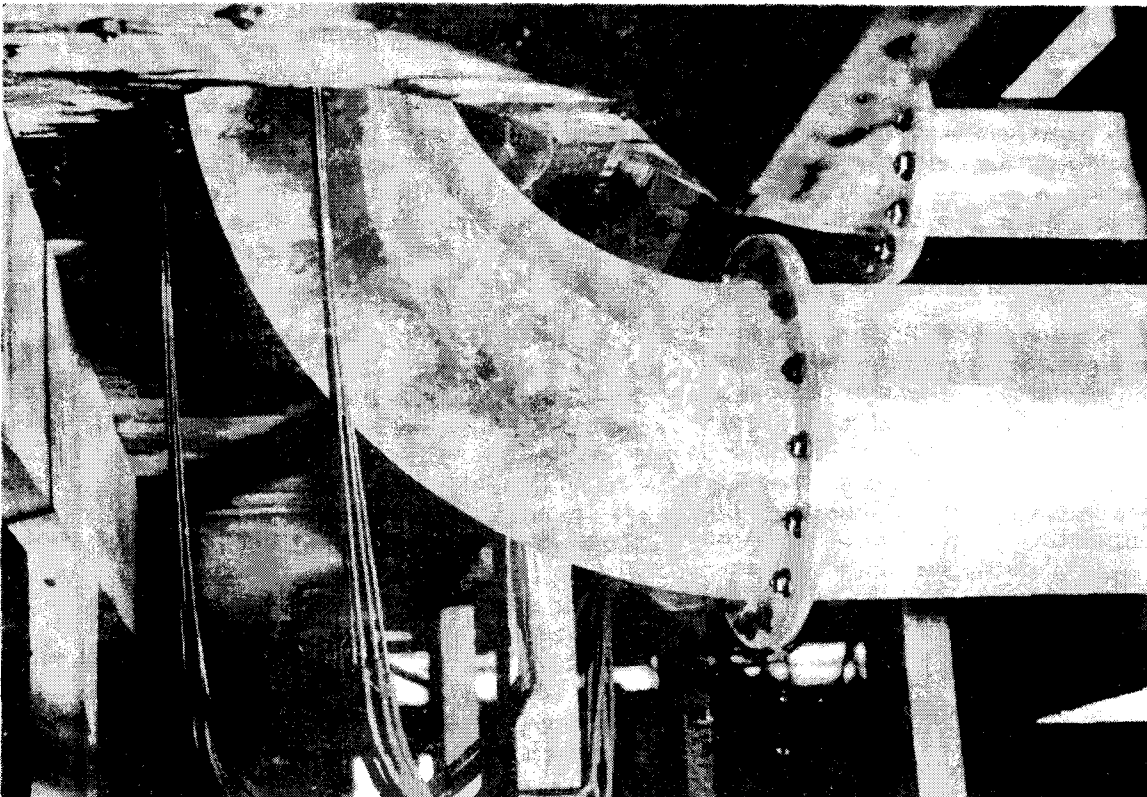
FIGURE 6--The deflector at the base of the vertical shaft produced smooth flow and a flat water surface in this test of the vertical bend at 3,750 cfs. Although the air flow appeared continuous to the eye, high-speed photographs showed that air entered the flow in bursts.

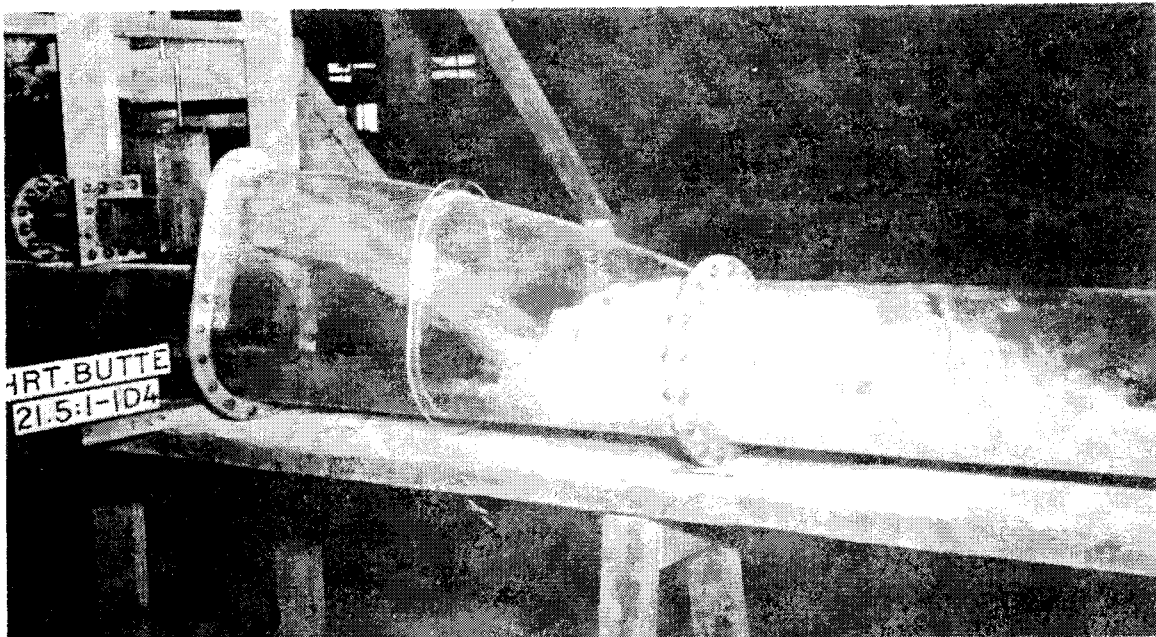
A--The short junction section recommended for use in the prototype caused some disturbance in the flow at the entrance to the spillway tunnel.

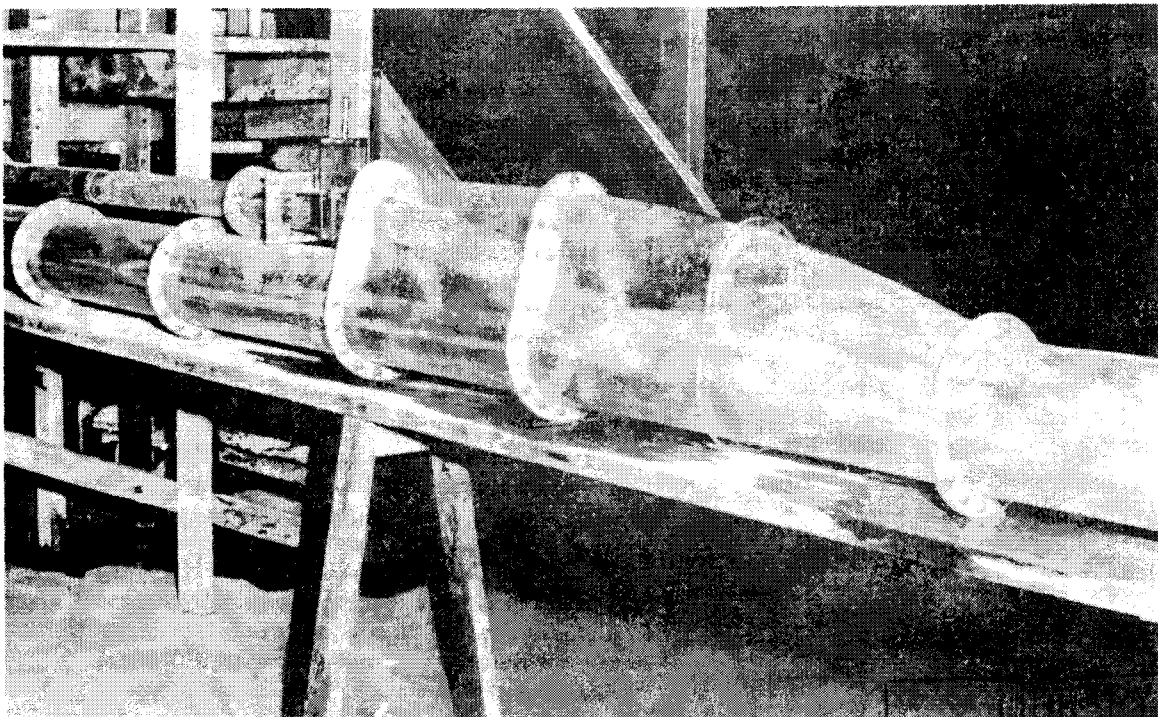
B--A considerably longer junction section was tested, but its greater cost was not believed to be justified, even though smoother flow resulted.

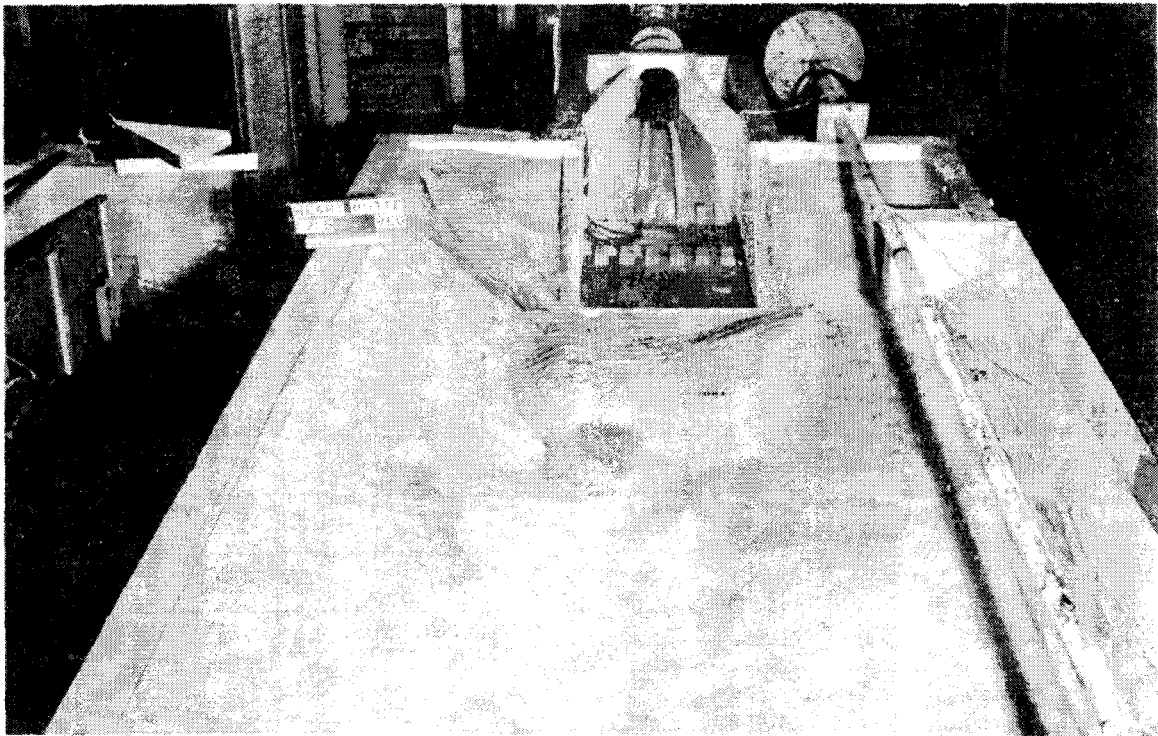
B--Although some erosion occurred, the operation was considered acceptable, since riprap protection was to be used in the prototype. The model produced the effect shown in a half-hour's operation.

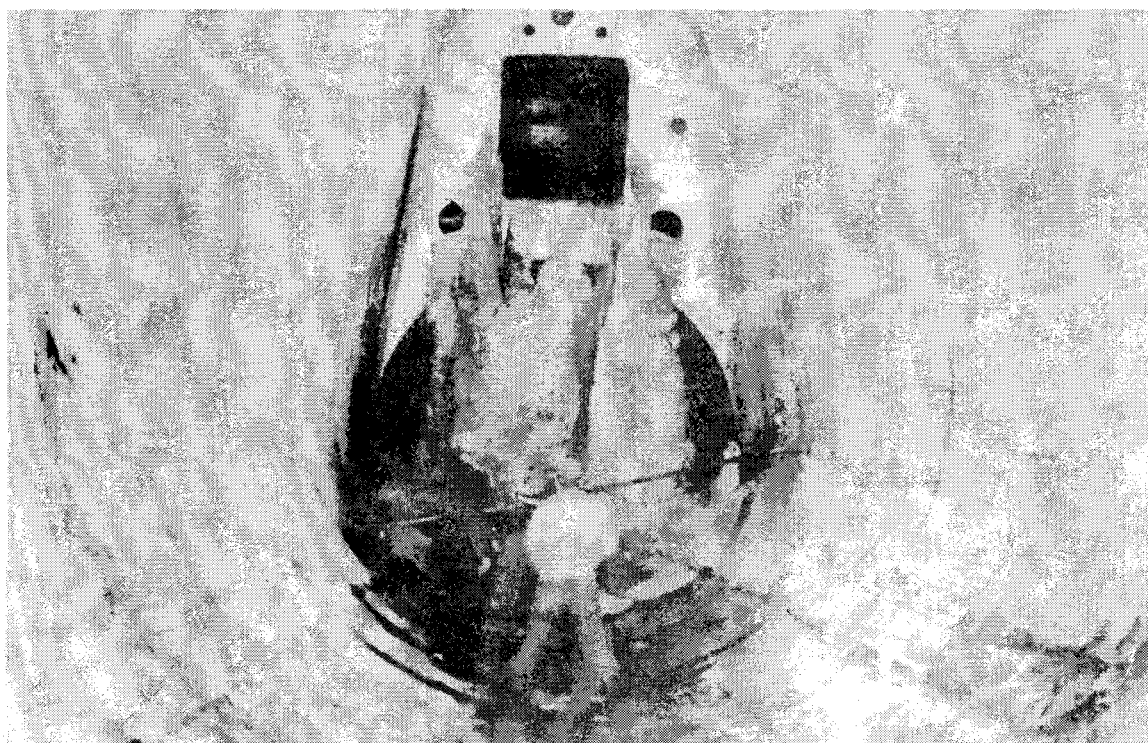
B--Ice that had formed from leaks around the outlet works control gate was removed before the spillway operated.

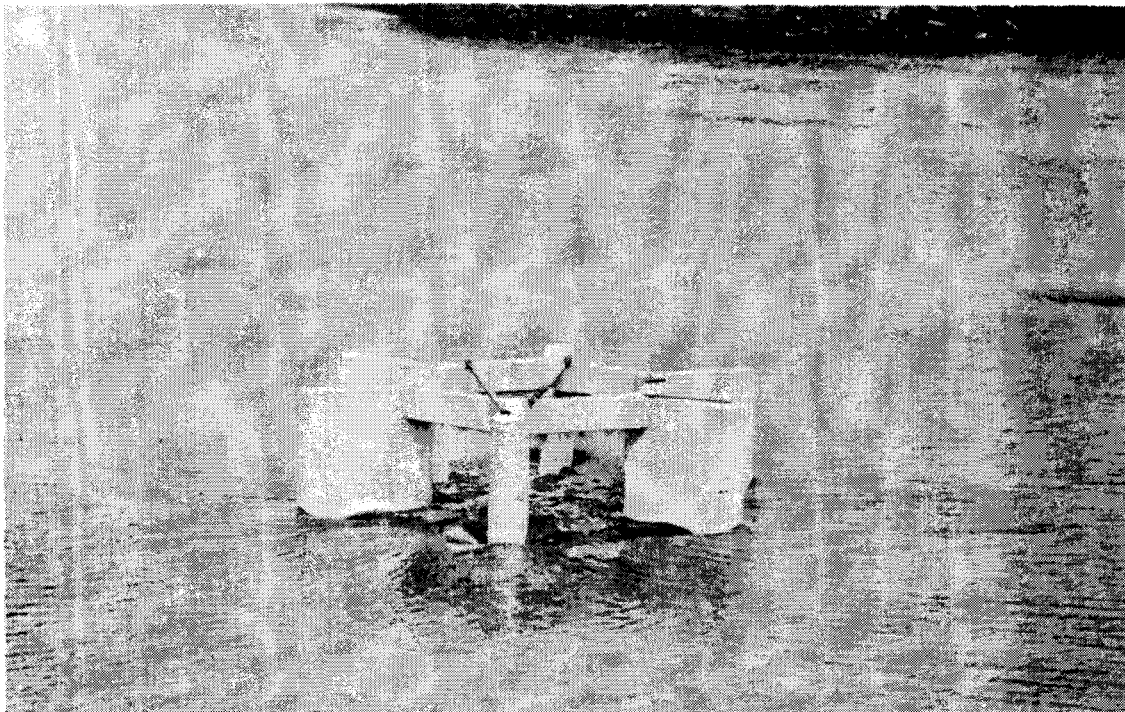
FIGURE 18--Spillway discharge was 3,090 cfs April 28, and reservoir elevation was 2071, about 0.7 foot above the point at which flow changes from submerged to free. The "mushroom" surged no more than a few inches.

The reservoir was down to elevation 2071 on April 28, or about 0.7 foot above the point where the flow changes from submerged to free discharge, see figures 18 and 12. The photograph indicates the mild condition inside the spillway. There was no pulsation or rising and falling of the "mushroom."

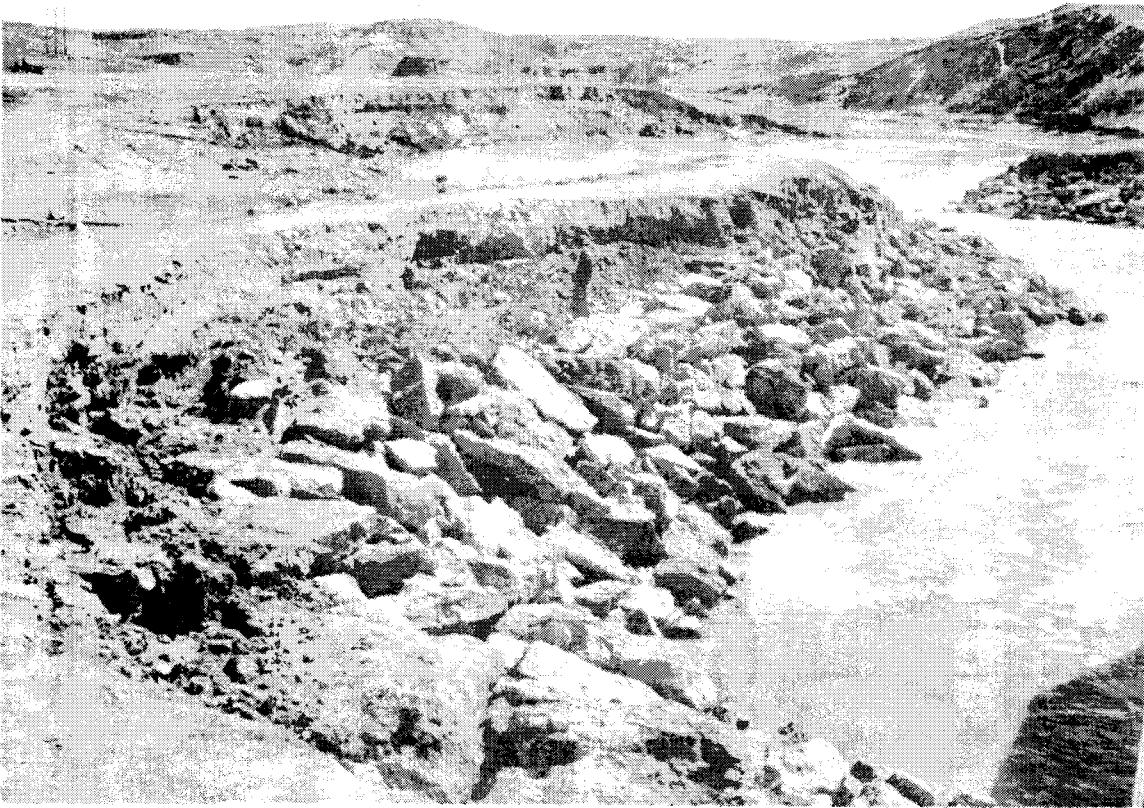
A--Swells eroded fine material from behind the coarse riprap along the left bank of the excavated channel below the stilling basin.

The channel banks, despite their riprap cover, were eroded to a greater degree. The riprap, however, had been placed in a thin layer, was not well graded as to size, and in places the earth banks could be seen between the individual rocks. Swells were observed to rise over local areas and penetrate very easily into the large voids. When the water receded, some of the earth was removed from behind the riprap. This was evidenced by the darker, earth-colored water which could be seen adjacent to the riprap. After several days of spillway operation, the riprap had slumped and the earth banks had caved as shown in figure 30. In spite of the apparent damage to the banks the riprap still continued to provide a good measure of protection against further cutting.

The bank damage was caused primarily by swells originating from surges in the hydraulic jump, and not by waves of the ordinary variety, since these were only a matter of inches in over-all height. The model stilling basin had been equipped with baffle piers and chute blocks to reduce the over-all length of the stilling basin and decrease its cost. It had been noted during these and other model tests that when a hydraulic jump is reduced in length by the use of artificial devices such as baffle piers that the jump becomes more stable in most respects, but it does exhibit a tendency to produce the swells discussed above. The swells are considered the lesser of the evils, however, and are not impossible to cope with. With a thicker application of well-graded riprap, there probably would have been no damage.

Inspection of the riprap downstream from the stilling basin, following the 1950 flood, indicated that repairs would be advisable. The slumped riprap in the channel immediately downstream from the stilling basin structure was repaired in May and June 1950. Gravel backfill was placed on the slopes to bring them to grade and rock replaced over the gravel. The eroded riverbank just downstream from the end of the riprapped channel was sloped and covered with gravel and rock.

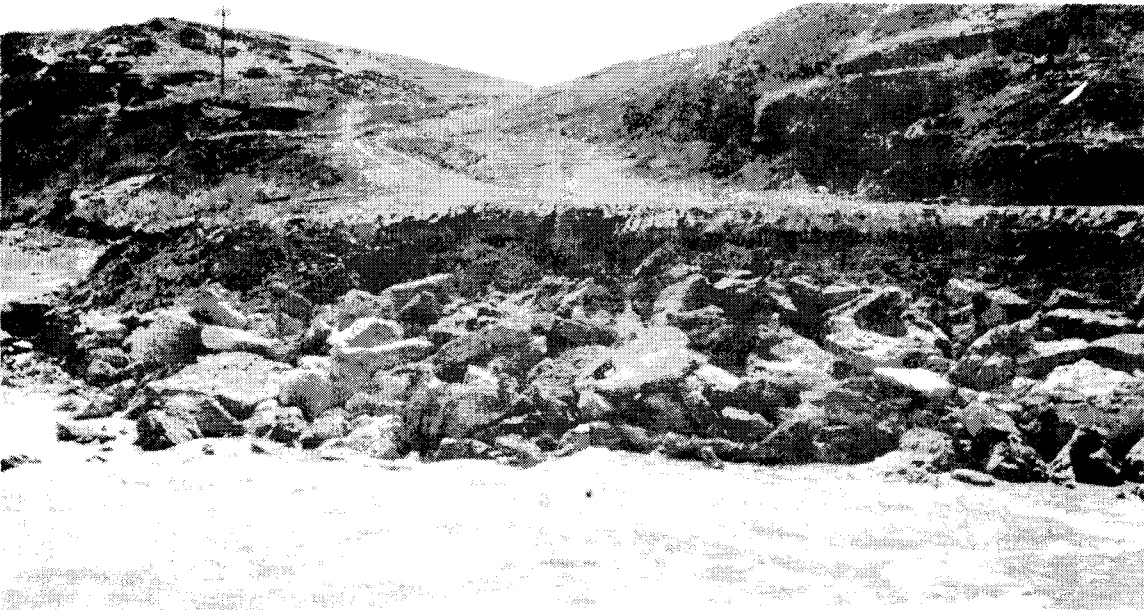
B--Erosion also occurred along the right bank near the junction of the natural river channel and the excavated channel below the basin.

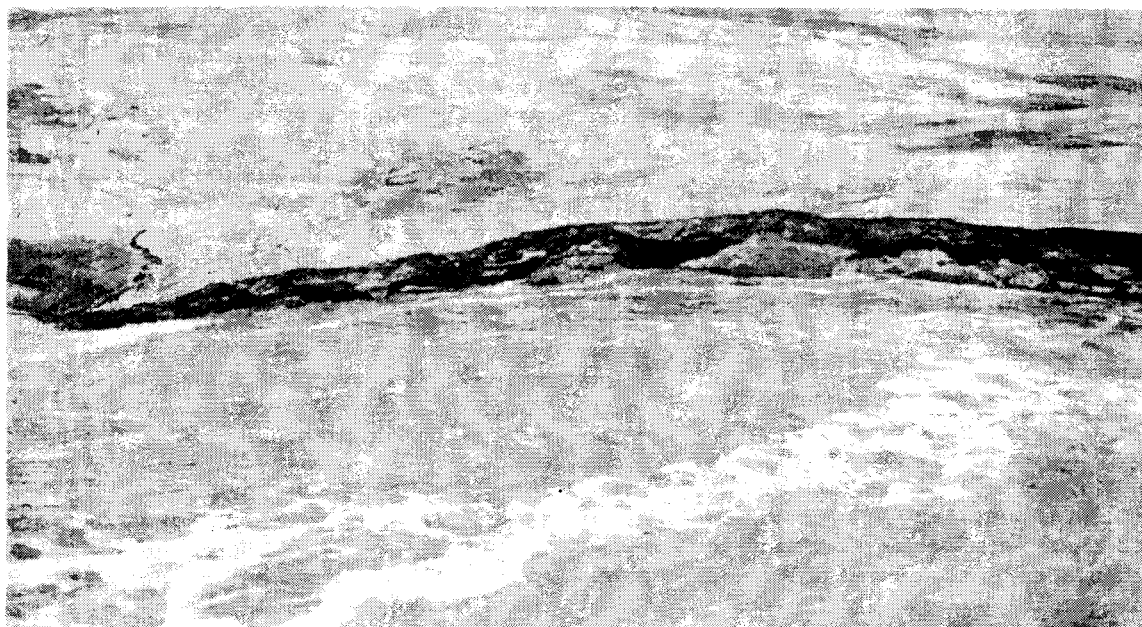
B--The high-velocity discharge into the natural channel set up a back eddy that damaged the river bank upstream from the point of impact.

proved to be sufficient to cause considerable damage to the unprotected riverbank downstream, see figure 32B. Some of the damage was caused by the direct effects of the current flowing diagonally across the river and cutting into the far or left bank. A great share of the damage, however, was caused by a large induced eddy in the river, see figure 32B. This eddy caused an upstream current along the left bank which removed large volumes of material from areas considerably upstream from the point where the main flow impinged on the bank. Although the damage was considerable in extent, it had no ill effects on the structure or its operation. Riprap placed in the eroded area will prove of value, however, since the damage would become greater with each successive run-off and the end result would be difficult to predict. The bank damage is illustrated in figure 33. A comparison of figures 23 and 34 shows the extent of the bank damage which occurred between the start of the run-off and May 5, 1950.

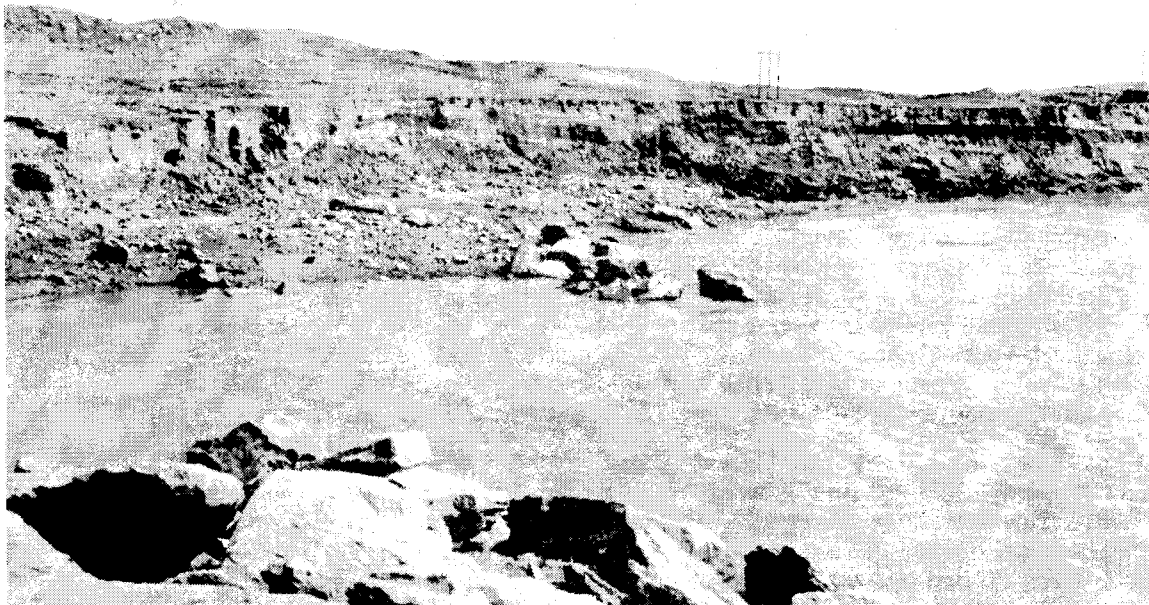
FIGURE 33--Loss of bank material through erosion during the 1950 flood is readily apparent. The eddy shown in figure 32-B caused this damage.

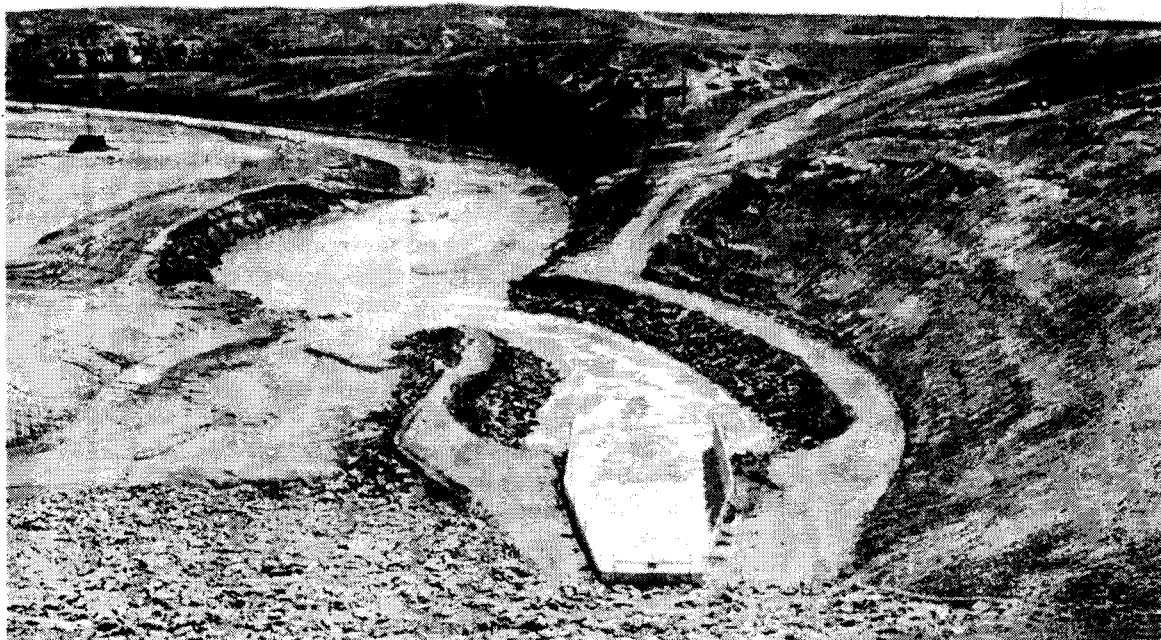
FIGURE 34—Extent of downstream erosion can be seen by comparing this view after the flood had receded with figure 23, at the height of the flood flow.

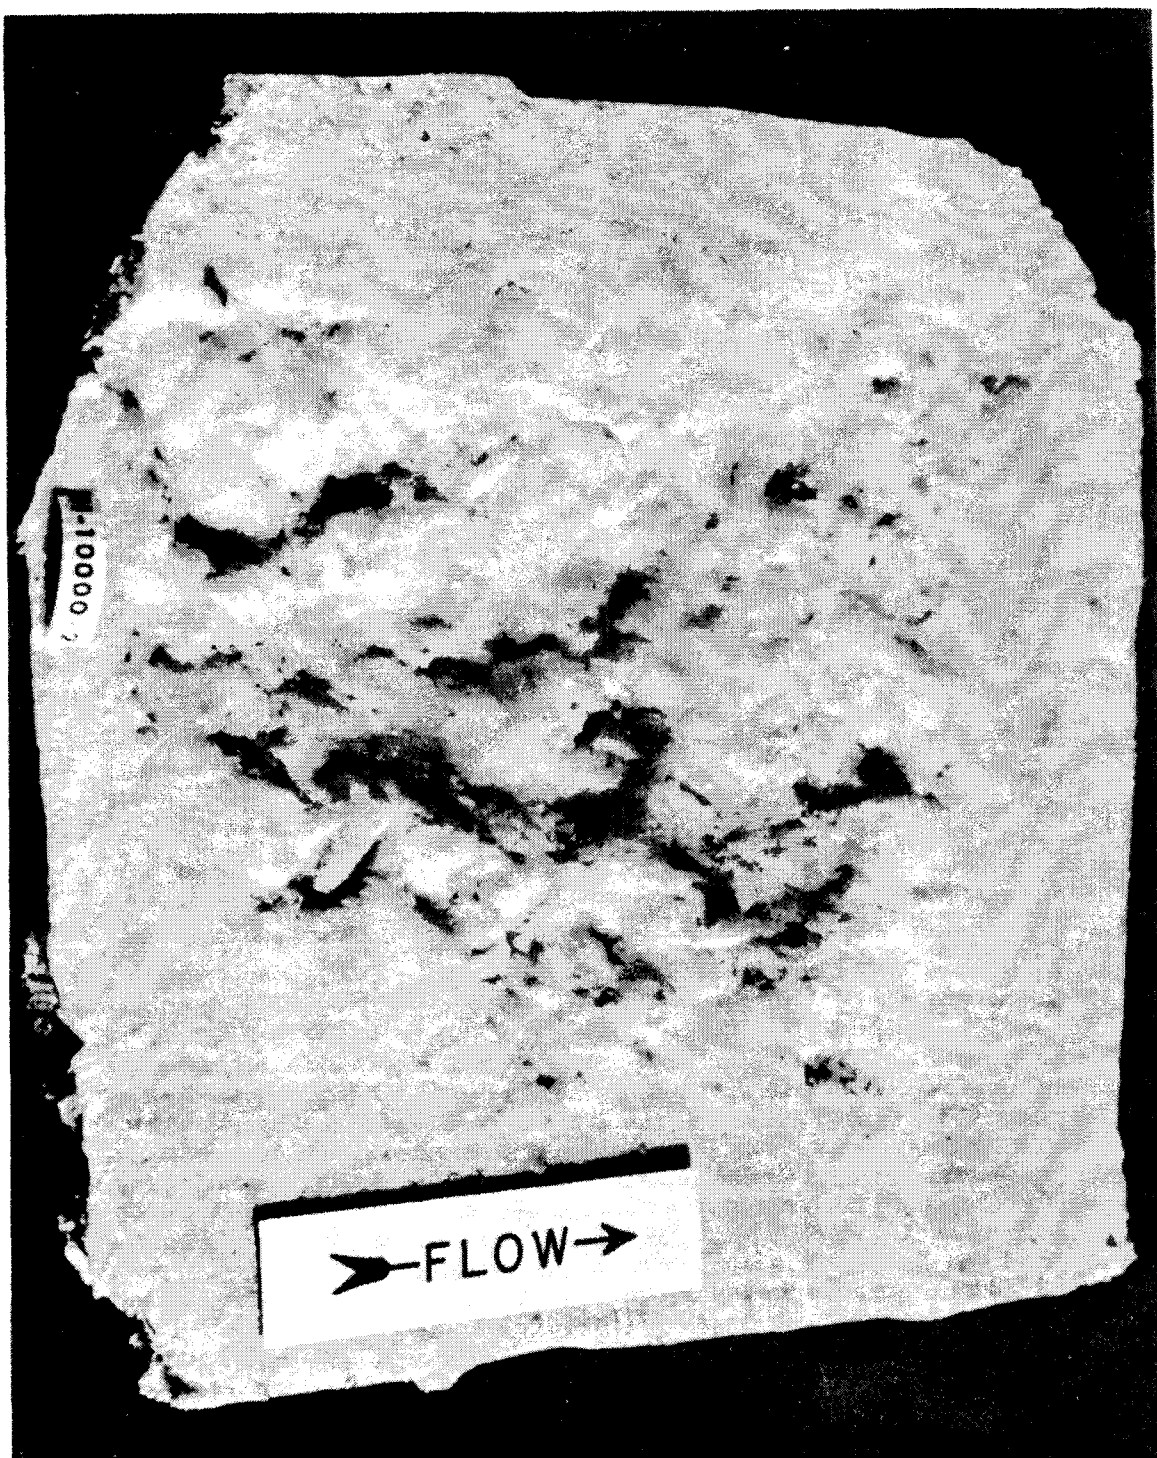
The conduit inspection, in both instances, revealed that the concrete was in excellent condition with the exception of four small eroded areas located in the 90° bend. Following the 1950 flood, plaster casts were made of the two most prominent areas. These are shown about full size in figures 35 and 36. The largest area is about the size of a man's hand and by actual measurement has a maximum depth of erosion of 3/4 inch. The smaller area shows a maximum depth of 1/2 inch. The surfaces shown in figures 35 and 36 were molded in sponge rubber against the plaster casts made in the field and are therefore an exact replica of the tunnel surface following the 1950 flood.

These areas are located near the invert and near the bottom of the 90° bend. Construction timbers or ice falling into the shaft could have caused the surface damage shown. Persons who have viewed the rubber casts have been of the unanimous opinion that the damage was not started by cavitation.

FIGURE 35--Eroded areas in the 90° bend subsequent to the 1950 flood were four in number. This, the deepest, is shown by a cast made in the bend from the actual depression. Erosion was 3/4 inch deep. The illustration is full size.

Following the 1951 flood, these areas were again noted. There did not appear to be any marked change in these areas as a result of the 1951 spring floods. No repairs were believed necessary.

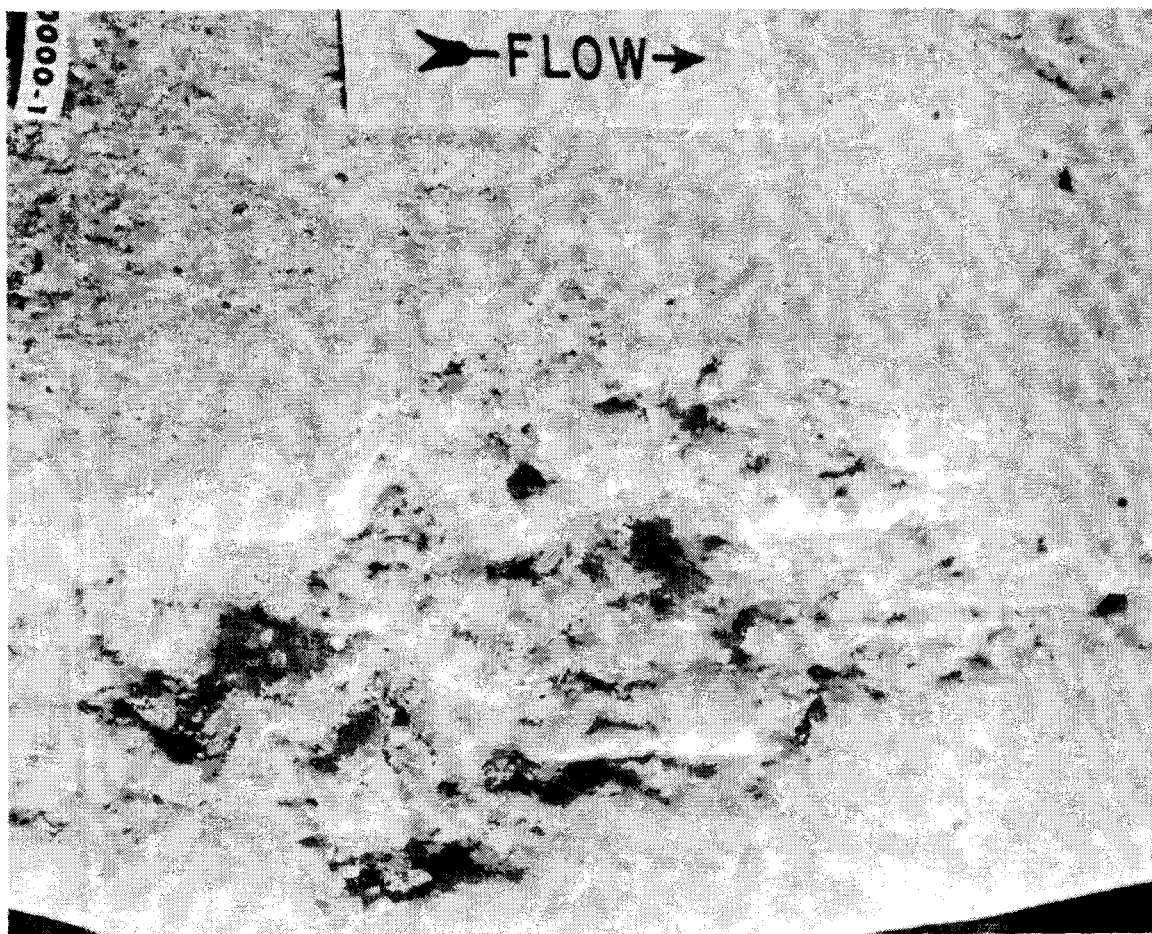
FIGURE 36--Another of the eroded areas is also shown full size. Depth of erosion here was 1/2 inch. The 1951 flood did not extend the size or depth of the eroded areas.

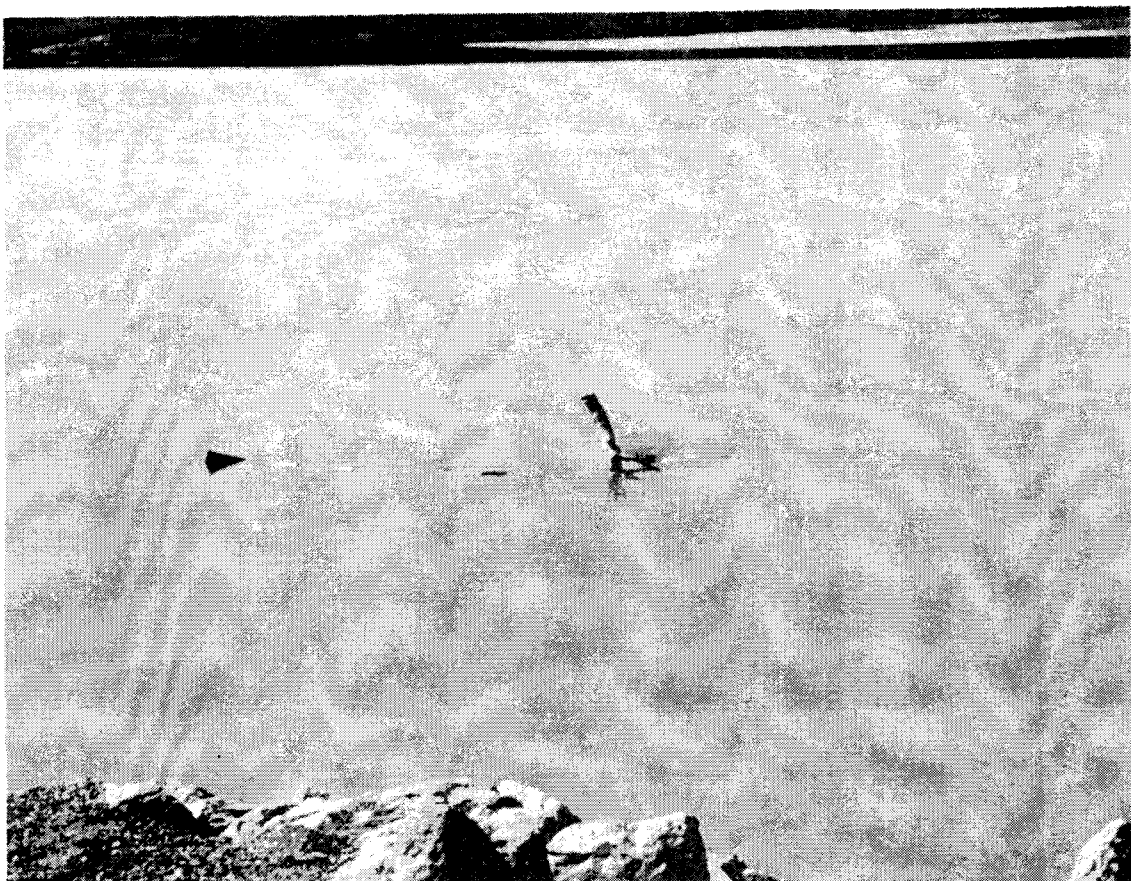
FIGURE 47--The vortex was continuous and did not shift laterally more than a few feet. There was no unusual noise. Tree trunk was 18 to 20 inches in diameter.

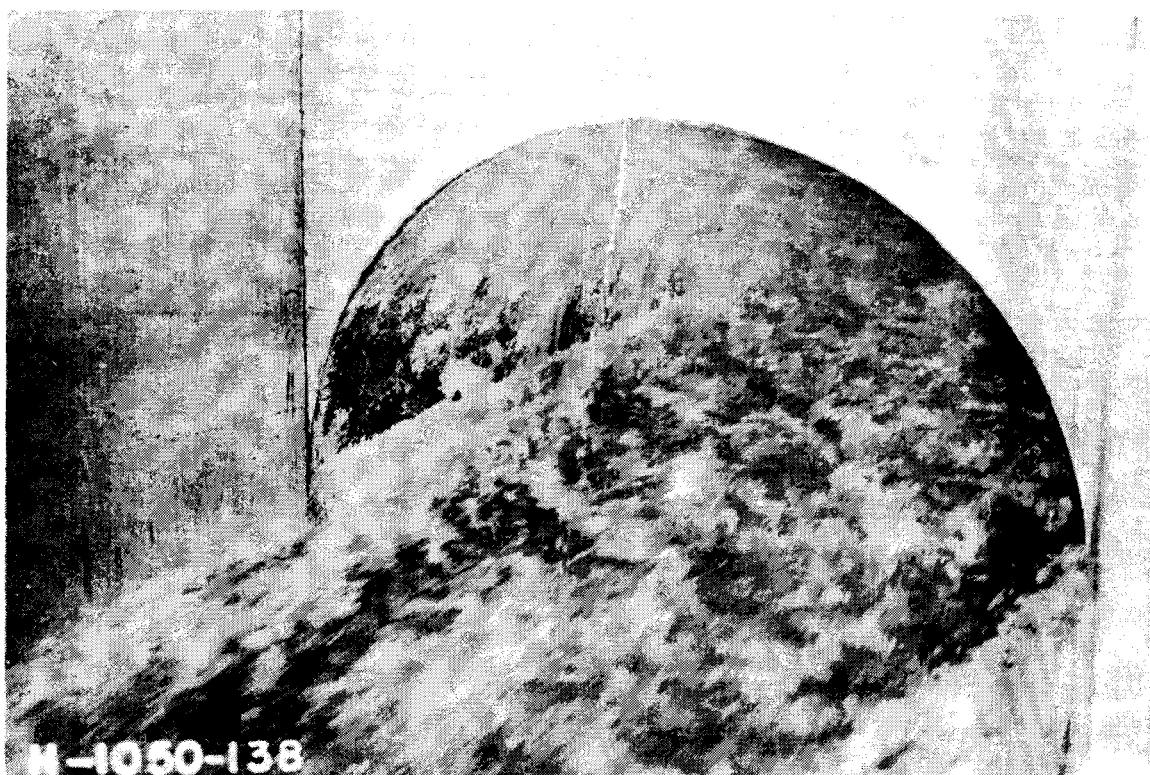
FIGURE 53--Trickle of water dropping straight down into flow at tunnel portal shows that air flow through the tunnel was not sufficient to deflect the trickle. Straw dropped into the flow showed only slight air movement.

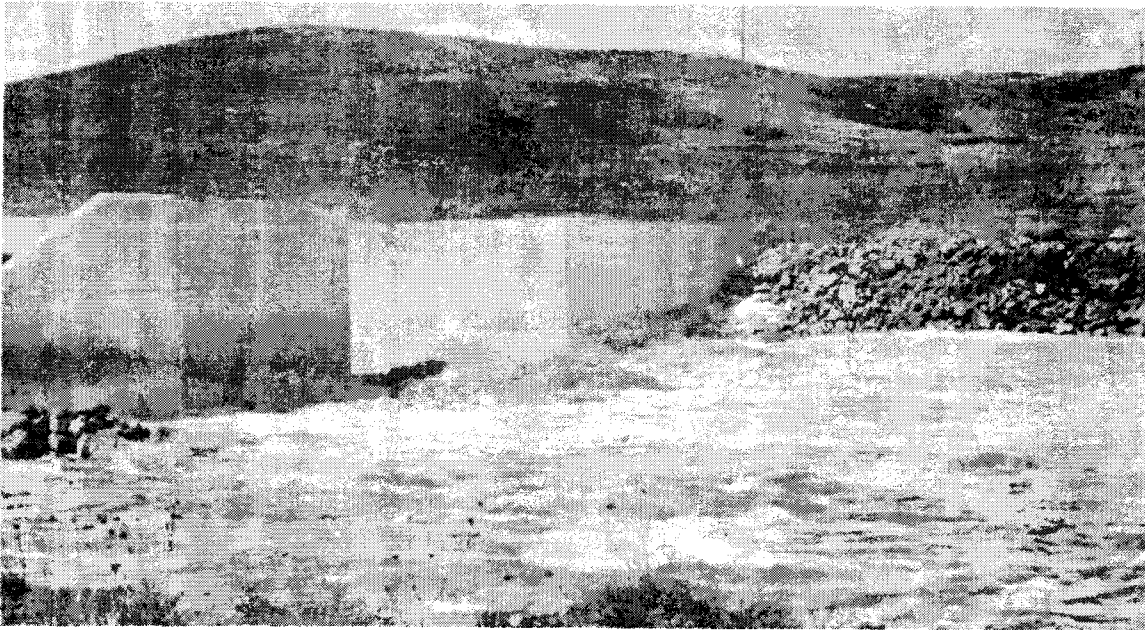
A--Boil at end of stilling basin extended into excavated channel, making exact determination of tail water elevation difficult.

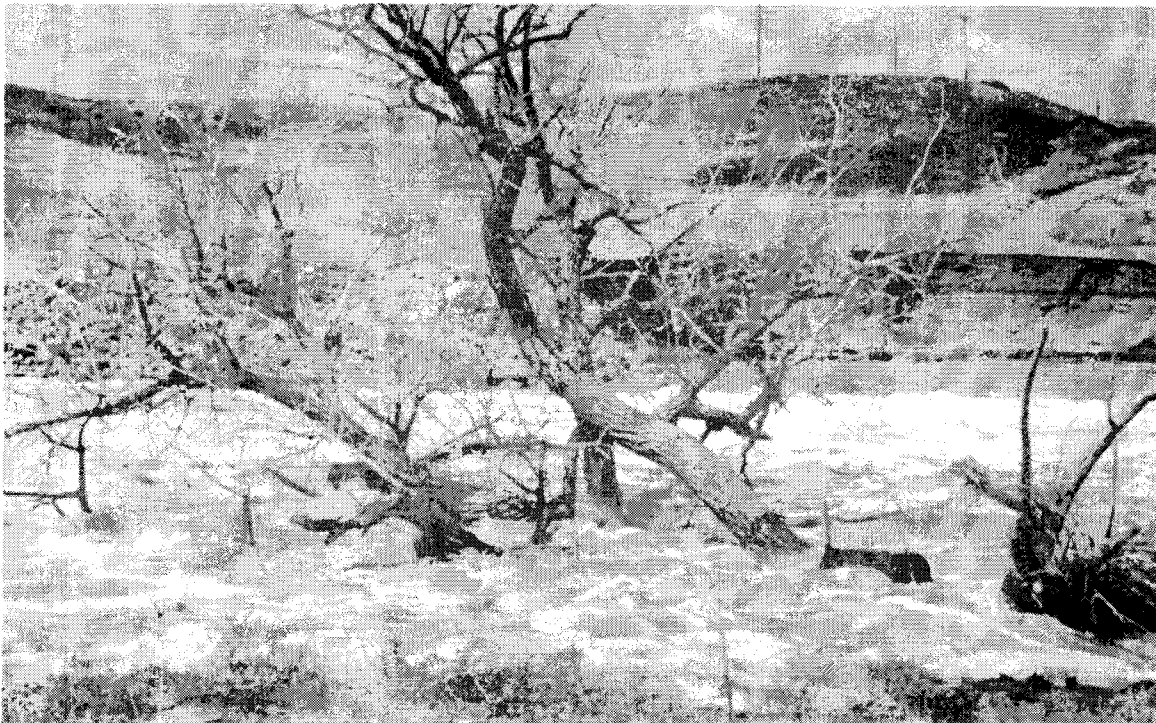
B--Erosion of channel banks isolated trees and widened the channel. Far bank was eroded by eddy cutting behind riprap. Oil drums caught in trees were part of safety boom that had passed through spillway.

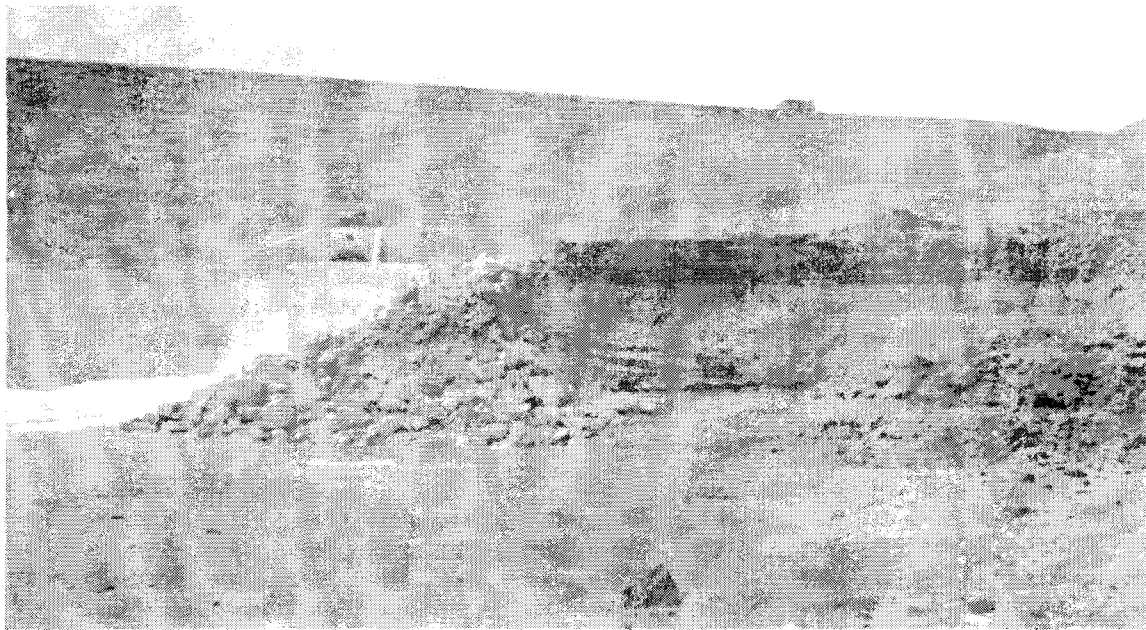
A--An eddy in the foreground area caused erosion of the bank. Riprap was attacked from behind.

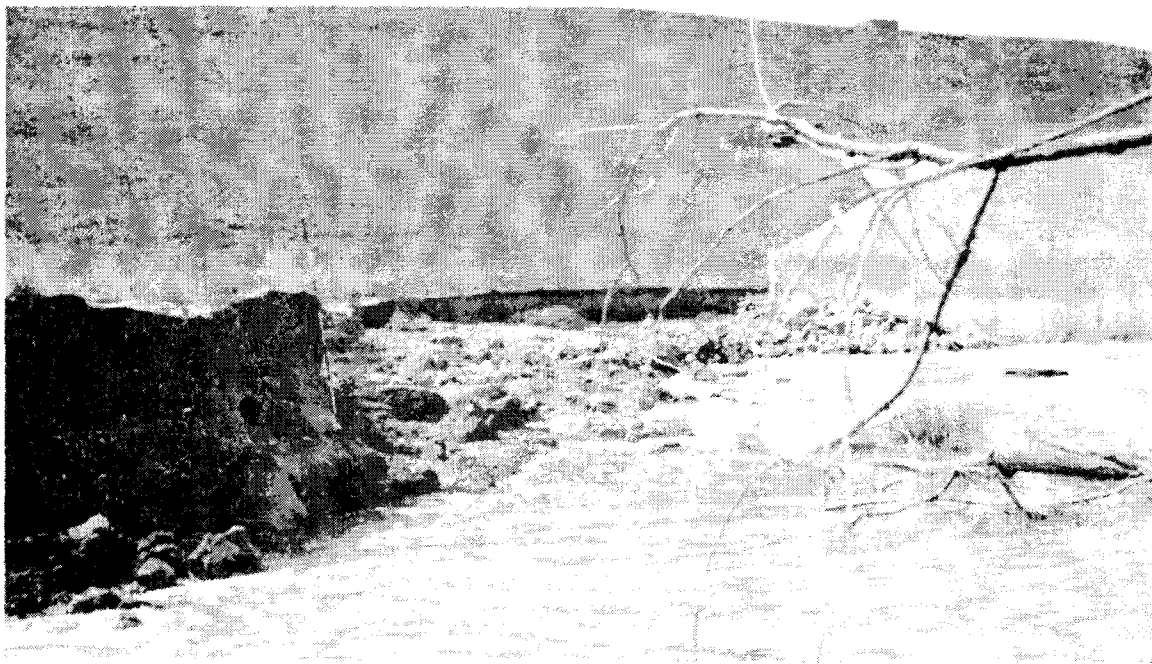
B--Low right bank was completely disintegrated. Trees to which the branches at right belong were on dry land before the flood.
